DisplayPort Expansion Card Power Saving Firmware Update

This guide allows owners of 1st Generation DisplayPort Expansion Cards to update to the 2nd Generation Firmware.

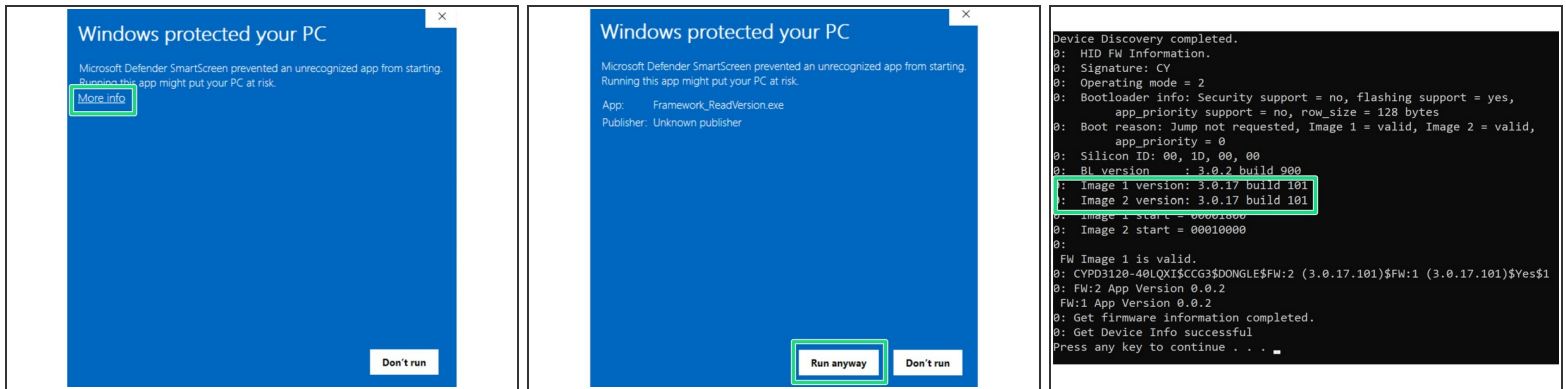
Step 3 — Check the current Firmware

- Run **Framework_ReadVersion.exe** to check that is not already on the 101 firmware.
 - ① If you receive an error about VCRUNTIME140.dll, make sure you have both the X86 and X64 versions of [Microsoft Visual C++ Redistributable](#) installed.
- ⚠ When trying to run the executable you will likely be prompted by Windows Defender. Simply click **More Info** and then **Run Anyway**.
- Once this runs you can check the **Image 1 Version** and **Image 2 Version**. In this image the build version is 101.

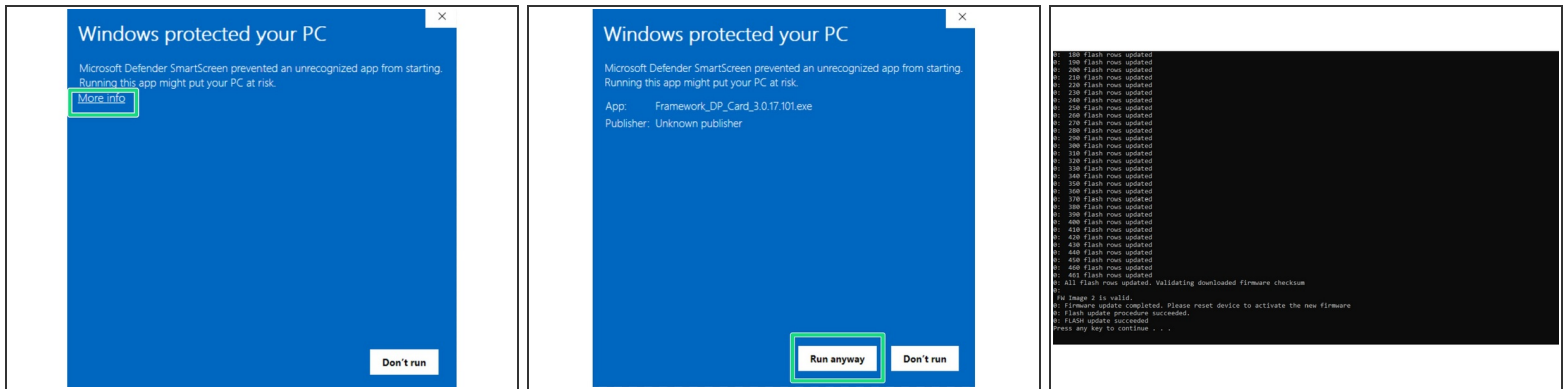
Step 4 — Run the Update executable

- Run **Framework_DP_Card_3.0.17.101.exe**

- The Flash process will be started automatically.
- Hit any key after it tells you to.
